General Info

Experiment ID: ex100922_2SpOT.5
 Date of Culture: 18 Aug 2010
 Type of Culture: 2 Spinal Organotypic
 Drug Applied: gabazine + strychnine
 Date & Time Applied: 21-Sep-2010, 15:00
 Date & Time of Recording: 22-Sep-2010, 16:22

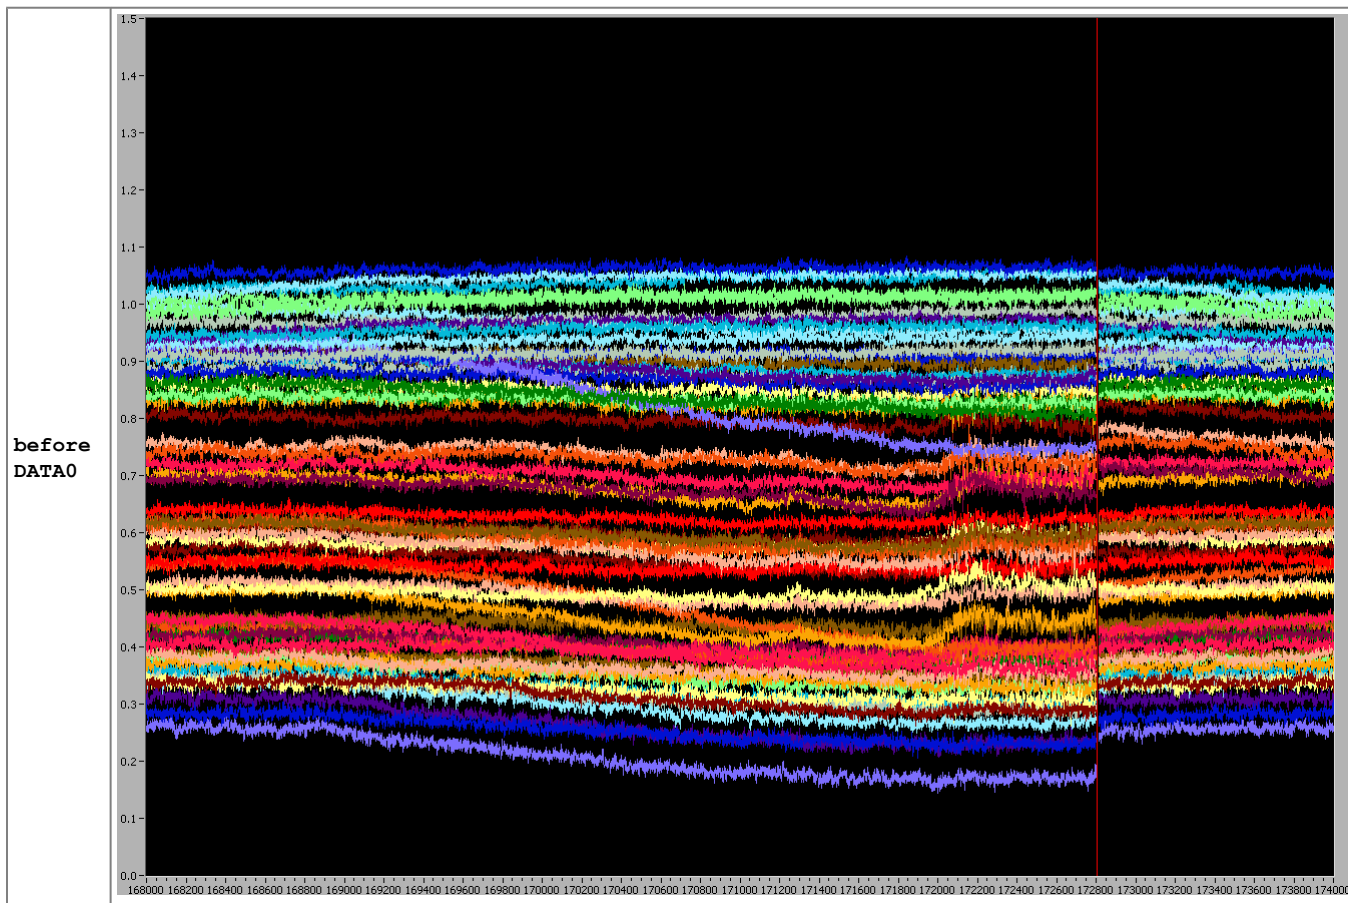
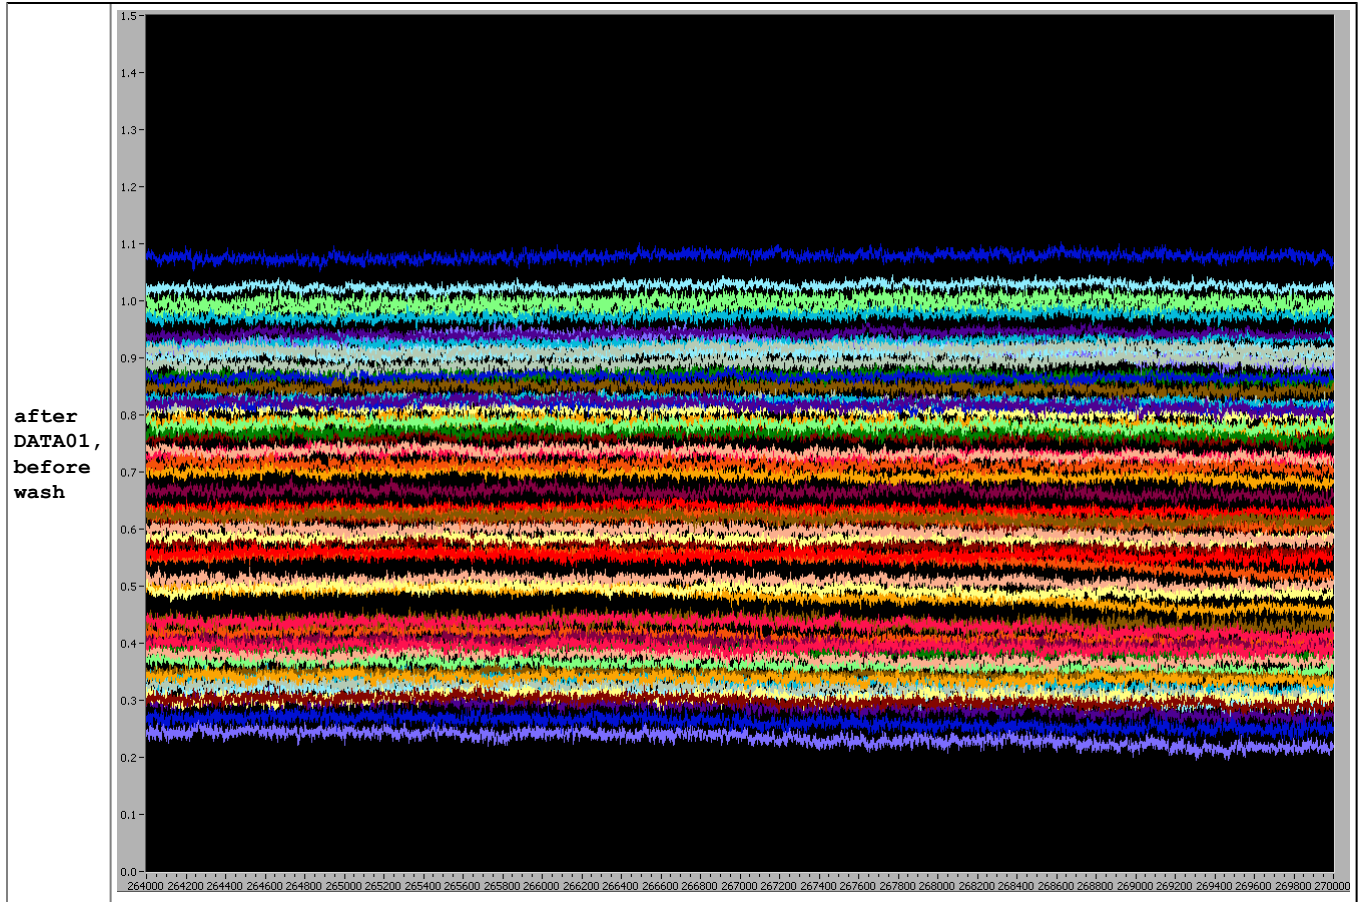
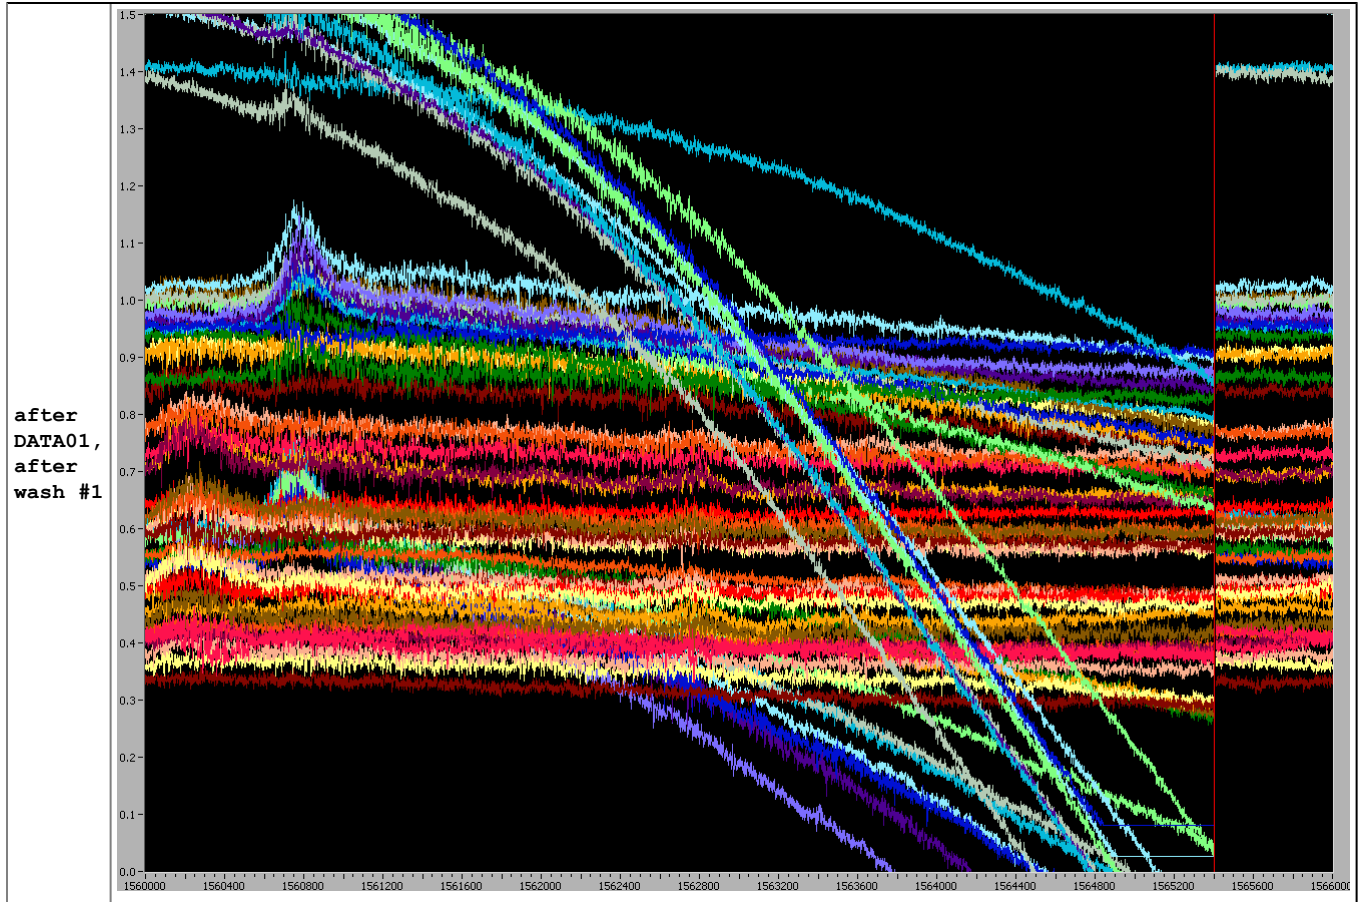
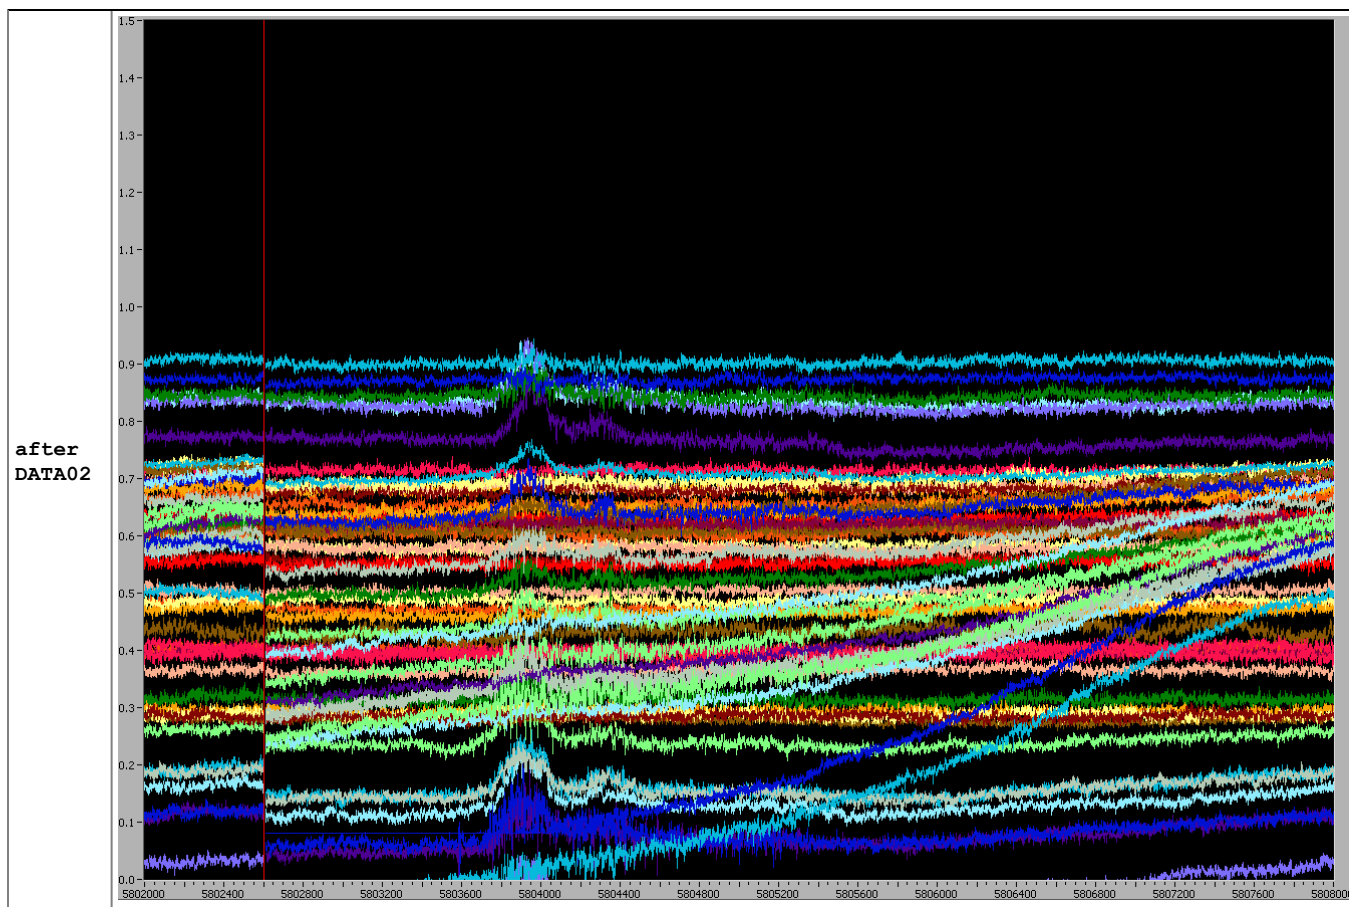
I've been having some problems with the headstage making good contact with the pre-amp, and this is (I think exacerbated by the humid environment). For this reason, some contacts look great early on, slowly drop out as the experiment progresses, and become particularly horrible when I perfuse in new solutions. In the next couple experiments I'll be trying different things and documenting performance.

Each the screenshots shows channels that were selected at the beginning of the recording. Those that are saturating out are the ones with flat waveform and low RMS.

The strategy that seems to work is to loosen the two bolts holding the right half of the array to the headstage about 1/2 a turn each. It is likely that the plastic spacer is slightly deformed such that the left side is not sitting as snugly. This approach alleviates this problem (at least seems to do so). In addition, I am removing the chamber from the pre-amp before changing perfusion solutions so that I can be as gentle as possible.
